## INSIGHT® Classic Stud Retainer Assembly Repair

The following information is provided to help you replace the seat and back onsert stud retainer assembly.

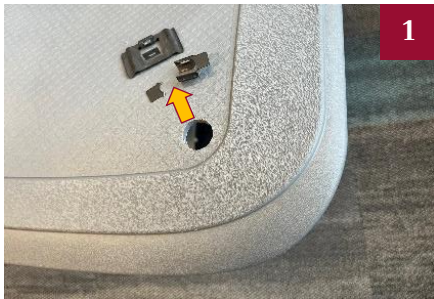
Remove all broken or malfunctioning stud retainer assembly components.

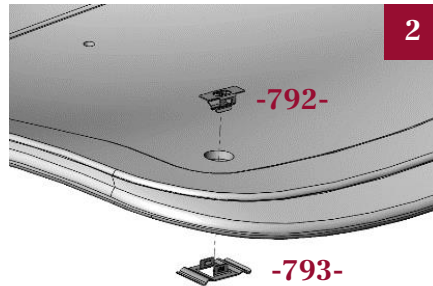
Stud retainer assembly includes upper spring clip (AS-PN 150-792-000) and lower clip retainer (150-793-000).

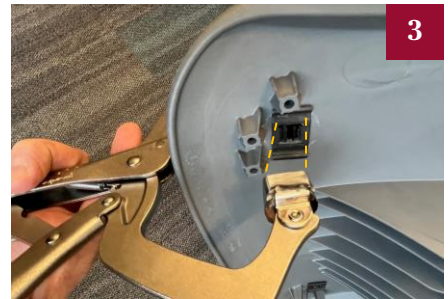
Hold in place the lower clip retainer into the bottom hole with clamp bottom (1 x 1" square tube section).

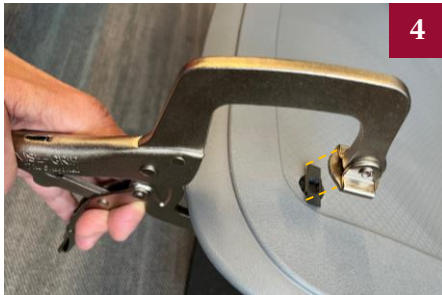
Position upper spring clip into top hole.

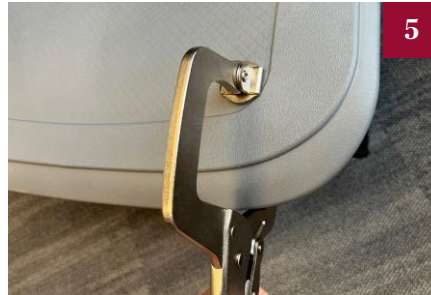
Close clamp to secure upper and lower components together. Should hear an audible click when they are connected.

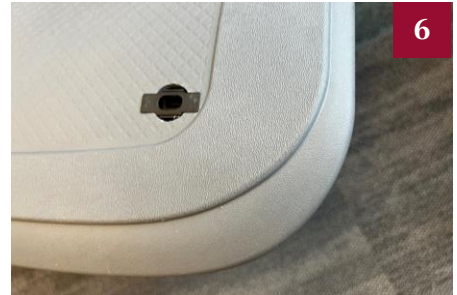
Finished assembly may rotate in the hole, but it is now ready to reattach onserts.
