## Vision<sup>®</sup> Stud Retainer Assembly Repair

The following information is provided to help you replace the seat and back insert stud retainer assembly.

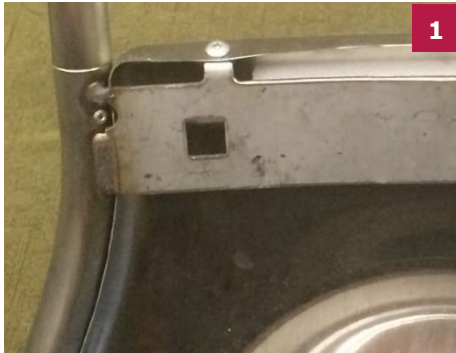
Remove broken or malfunctioning stud retainer assembly. **Note:** Upper retainer assembly is not used for Non-Upholstered (Vision-NU) seat backs.

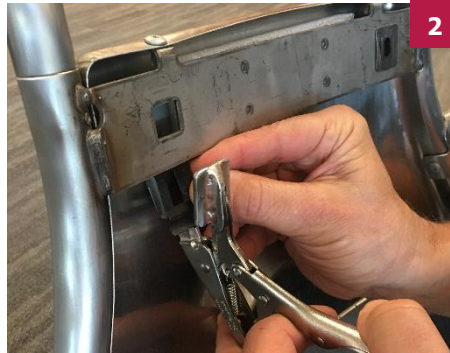
Position one stud retainer bottom behind the back strap and lined up with the openings. (AmSeCo part number: 114880000)

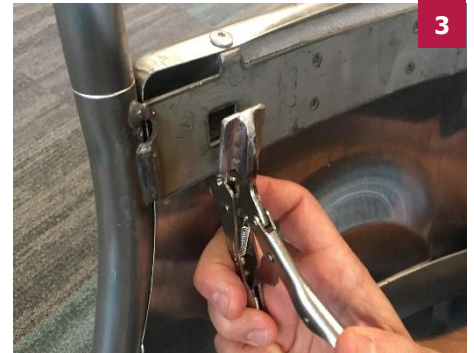
Hold in place with clamp bottom ("U" shaped section).

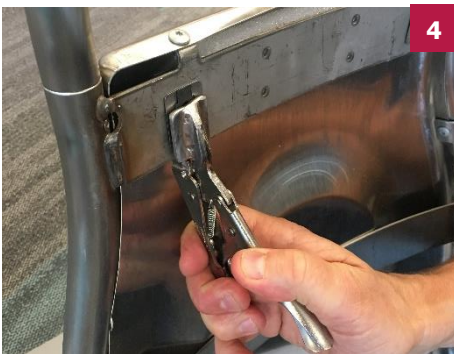
Position top of stud retainer assembly (two parts, see next image) and firmly clamp together to secure.

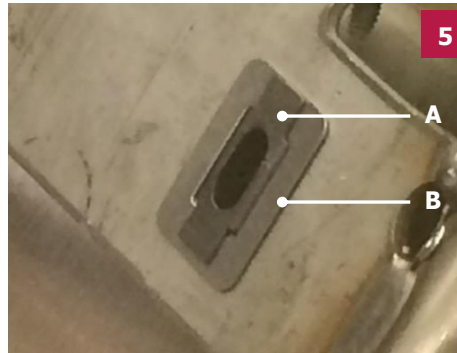
Repaired stud retainer. Item A is the stud retainer upper and item B is the guard. (AmSeCo part numbers A: 114879000 and B: 155451500)

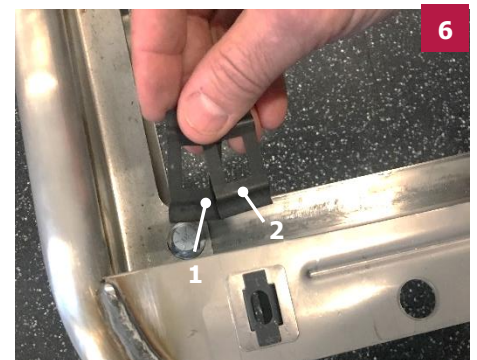
**Note:** All other locations use two (2) stud retainers under thinner (formed) straps. Front seat strap shown.
